NATIONAL TRANSPORTATION SAFETY BOARD

HAZARDOUS MATERIALS ACCIDENT REPORT

DERAILMENT OF
A CSX TRANSPORTATION FREIGHT TRAIN
AND FIRE INVOLVING BUTANE
AKRON, OHIO
FEBRUARY 26, 1989

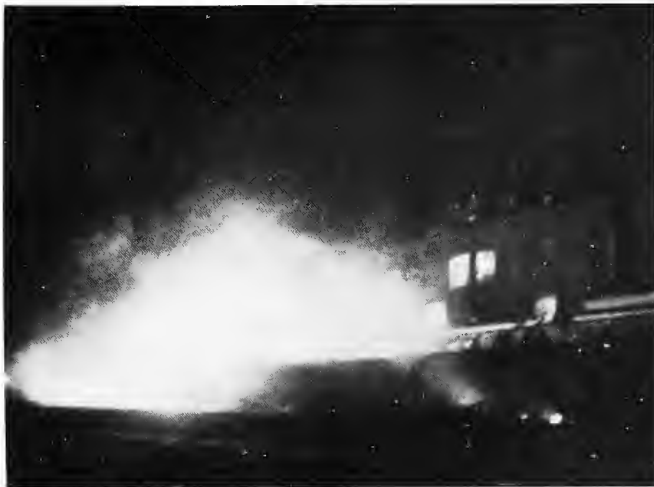
Figure 4.--Derailed tank cars adjacent to building 315.

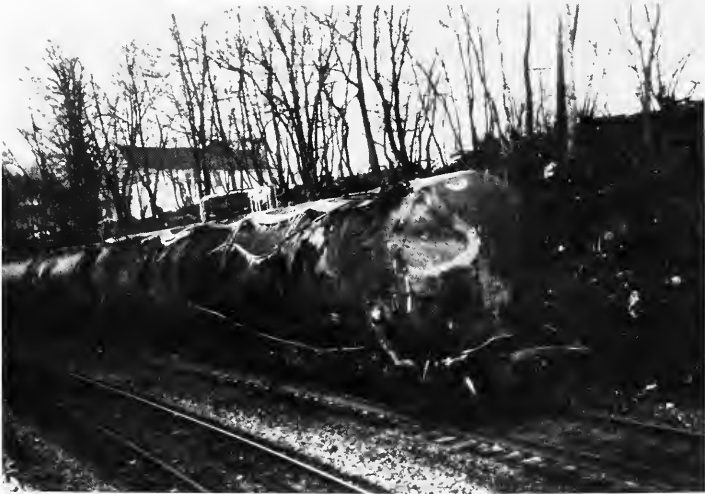
Figure 10.--Tank car BCDX 474.

BCDX 474 (DOT specification 105J300W). The A-end head shield sustained three impact dents, one about 4 feet in diameter in the top half (figure 10). The jacket on top of the tank sustained dents of about 2 feet and 1 foot in diameter. The tank car jacket sustained tears and wrinkles from heat exposure.

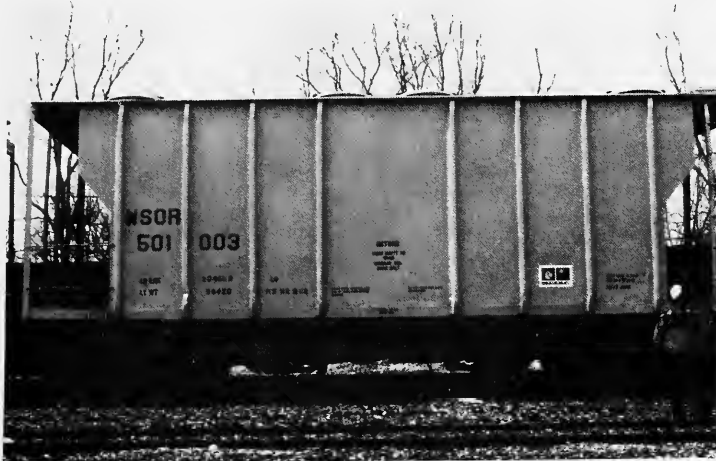
Figure 11.--Freight car WSOR 501003.

After the derailment near the B.F. Goodrich plant, WSOR 501003 was observed turned over on its left side (direction of movement of the train). The A-end truck was separated from the car and was found about 50 feet south of the derailed car. The B-end truck, which was the lead truck in the direction of movement of the train, was also separated from and in line with the car. Heavy rail burns were observed on the left sideframe of the B-end truck and wheel marks were observed on the left side cross-ridge slope sheet of the car (figure 12). Additionally, the lead wheelset showed evidence of heavy chaffing and bluish discoloration on the steel rims and flanges. Some of the springs were dislodged from the right sideframe of the B-end truck assembly. Figure 13 identifies some pertinent components of a truck assembly, including the bolster and sideframes.

After WSOR 501003 was rolled upright on its own trucks, the truck bolster on the A-end of the car was observed to be a different design from the truck bolster on the B-end of the car, and that the truck bolster pattern numbers were different. The A-end pattern number was Scullin AAR-B-1925 and the B-end pattern number was Gould-B-9S-14EJ-BX.

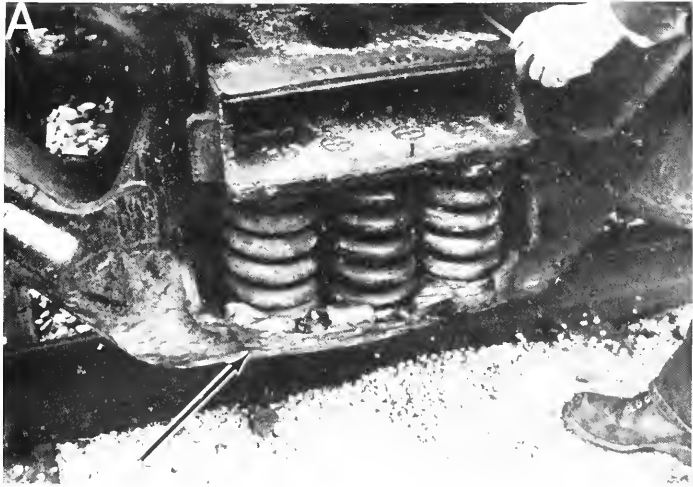
Figure 12.--Some of the damage observed on car WSOR 501003:
(A) rail burn on sideframe, (B) wheel marks on slope sheet.

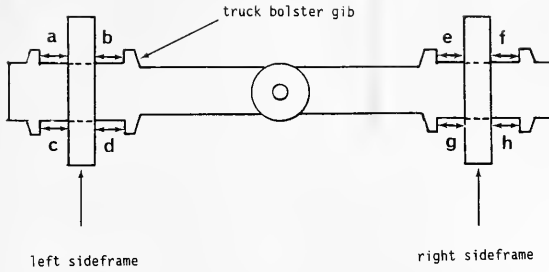
$a = 2$ inches	$e = 1 \frac{7}{8}$ inches
$b = 1 \frac{1}{4}$ inches	$f = 1 \frac{1}{4}$ inches
$a + b = 3 \frac{1}{4}$ inches	$e + f = 3 \frac{1}{8}$ inches
$c = 2$ inches	$g = 1 \frac{3}{4}$ inches
$d = 1 \frac{3}{16}$ inches	$h = 1 \frac{3}{8}$ inches
$c + d = 3 \frac{3}{16}$ inches	$g + h = 3 \frac{1}{8}$ inches

Figure 14.--Gib clearances measured between truck bolster gibs and sideframes on the B-end of WSOR 501003.

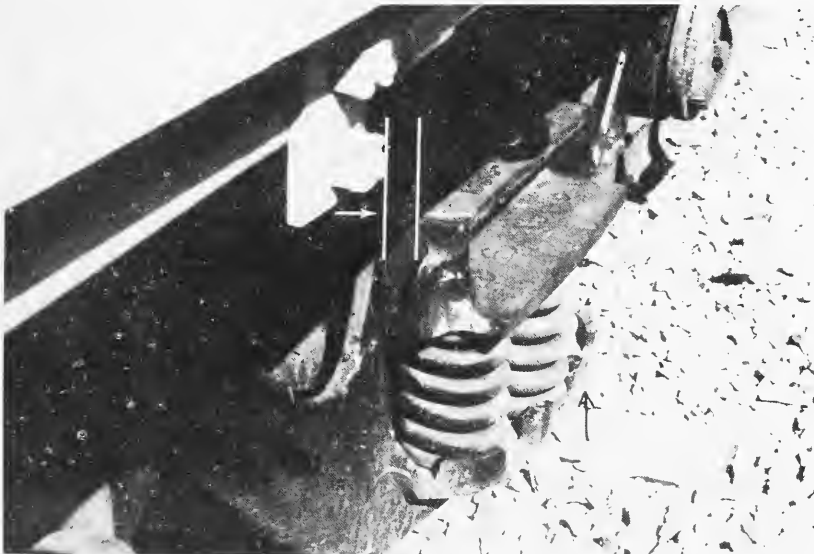
Figure 15.--Gib clearance visible outside the sideframe.

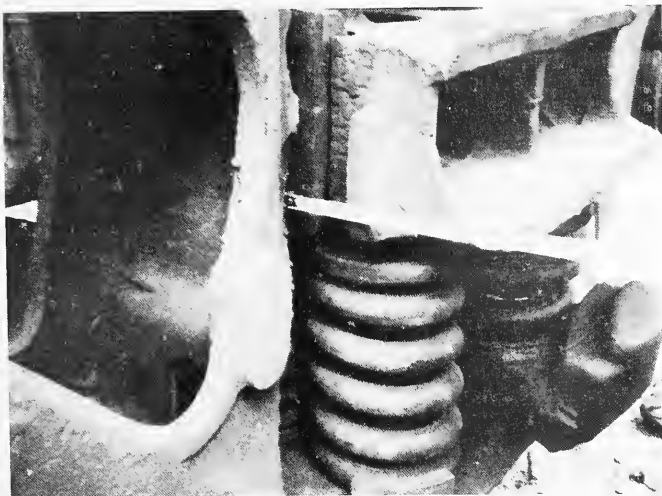
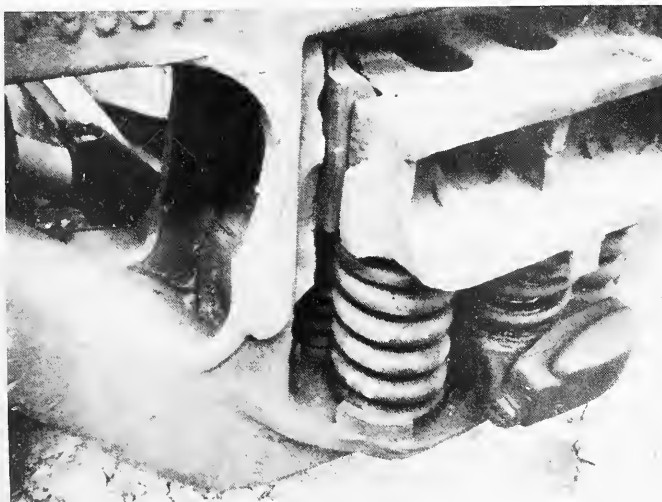
Other Car Repair Information.--Following the postaccident detection of the mismatched truck bolster on WSOR 501003, the owner of the Wisconsin & Southern Railroad told his car inspectors to look closely for mismatched bolsters on other cars. On May 10, 1989, Wisconsin & Southern Railroad car inspectors found a freight car with excessive gib clearances. This car, CNW 69883, was loaded with sugar and offered at interchange by the Chicago and North Western Transportation Company. The sideframes at both the A- and B-ends had been damaged as a result of contact with the truck bolster (figure 17).

Figure 17.--Damage to the sideframes of car CNW 69883.

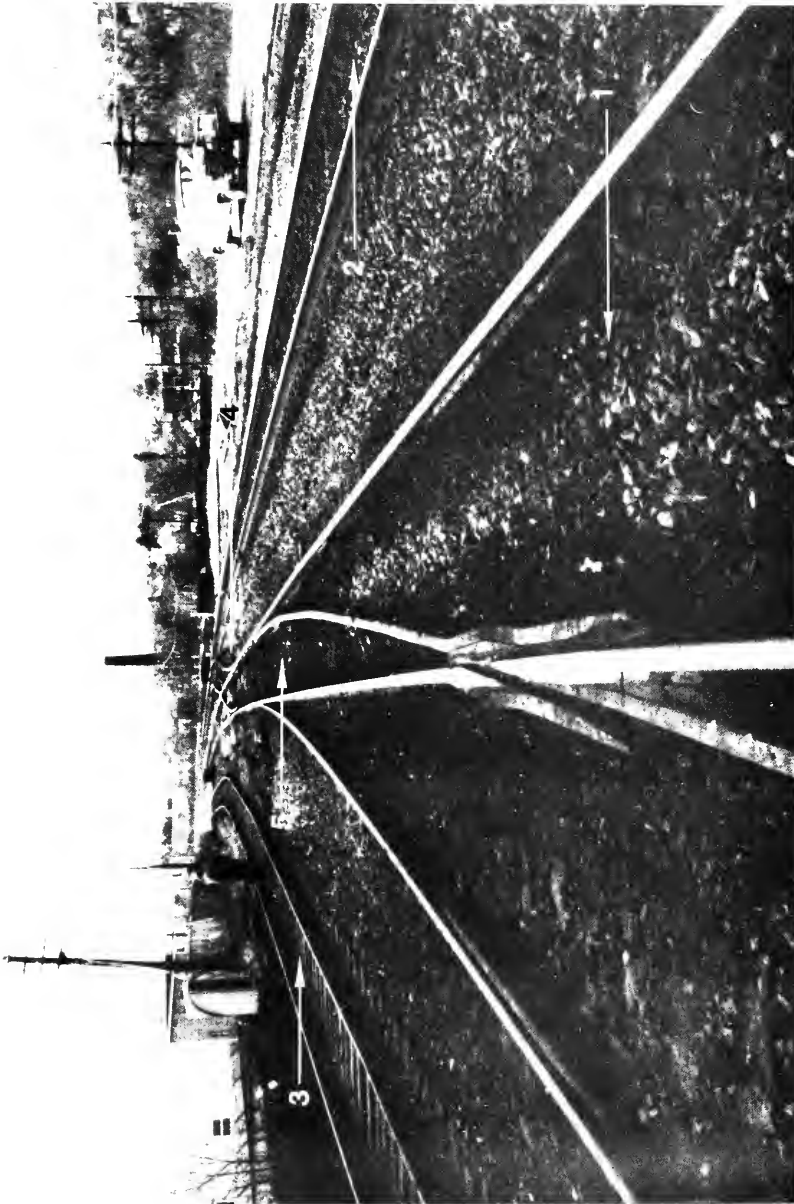
Description of Physical Evidence.--A postaccident inspection of the track approaching the point of derailment revealed discrepancies in the curve alignment and the track surface. The uniform alignment of the 1 degree 30 minute curve was interrupted by segments of irregular alignment caused by the presence of two turnouts located in the body of the curve. Throughout the curve, the high rail was curve-worn. However, at the toe of the trailing point frog, the rail wear tapered onto the closure rail for 14 feet, where it gradually tapered to no curve wear. Twelve feet north of the point where the high rail wear ended, wear was visible on the low rail for about 17 feet.

Figure 18.--View of tracks at accident site facing south. Arrows identify the following: (1) northbound track, (2) southbound track, (3) auxiliary track, (4) first turnout (direction of train movement), and (5) second turnout and area of point of derailment.

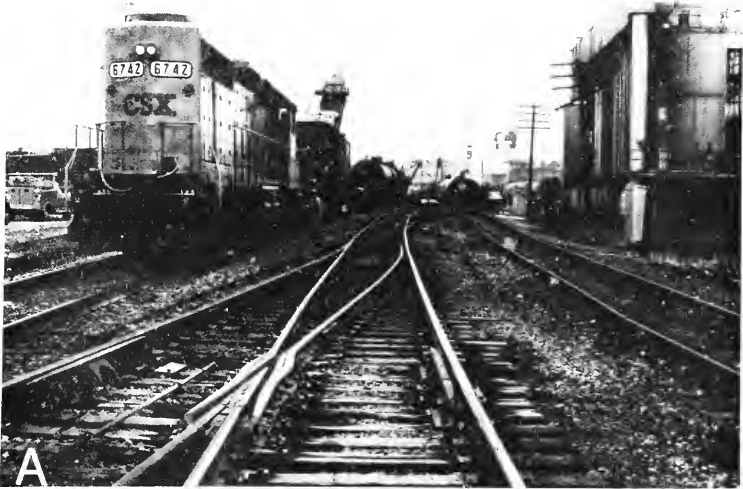
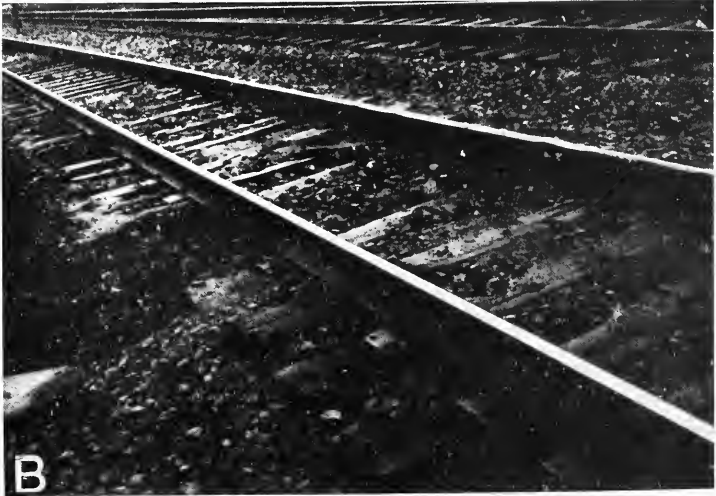
Figure 19.--Muddy track conditions on the northbound track: (A) at the turnouts, and (B) at the bridge south of the derailment site.

An abrasion was found on the receiving end of the guard rail in the trailing point turnout. The abrasion was on the guard face wing, about 1 1/2 inches beyond the area of normal contact between the back side of the car wheels and the guard rail. The abrasion was oxidized with a brightly colored rust, consistent with recent origin. The source of the abrasion could not be determined. Additionally, rail corrugation, caused by wheel forces, was found near the bridge immediately south of the accident site (see figure 19B).
